# Arborist Evaluation & Recommendations

PENINSULA  
ENVIRONMENTAL  
GROUP, INC.

**Report Date:** 6/25/19 **Project Number:** PEG0103

**Project Name:** Bayview Village Detention Pond

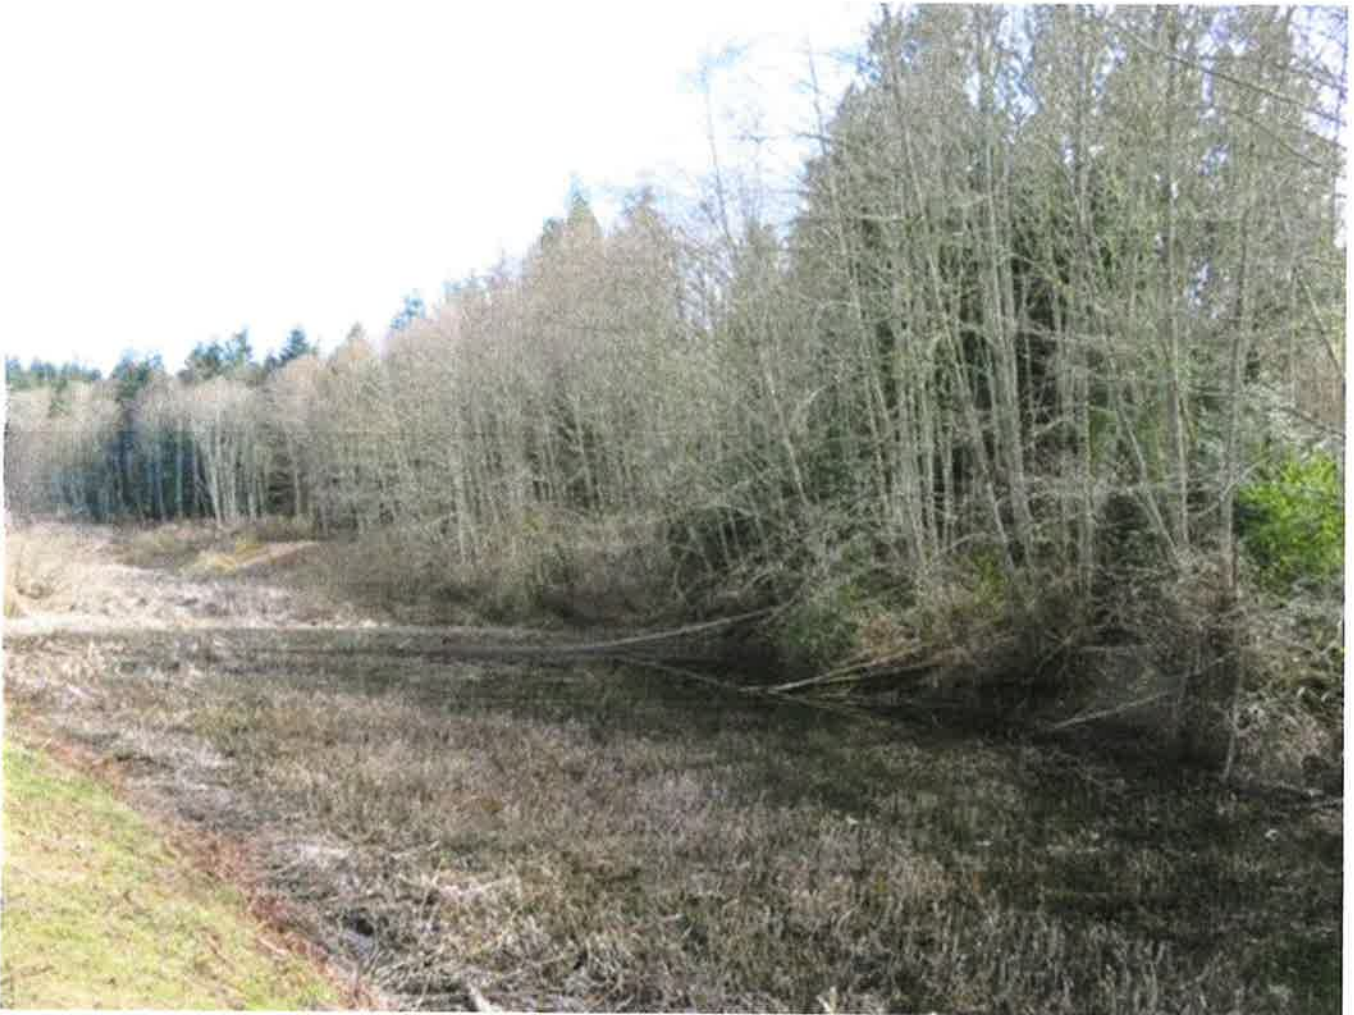
- The stand of alder trees is growing along and into the detention ponds along their southern edge. At least one of the alder trees has collapsed into the pond, and there are numerous saplings growing from within the pond.

- The detention ponds are almost entirely filled with detritus and decaying plant matter from the annual leaf-fall of red alder. According to the HOA, the routine dredging of sediment that should occur has not been possible due to the presence of the alders, which block equipment access. Due to this, the detention ponds are filled with sediment.

*Photo 1: Alders growing on Southern edge of detention ponds*

- We recommend the full removal of red alders, per Coastal Solutions LLC report dated January 5<sup>th</sup>, 2016.
- The cut red alders should be removed in a manner that minimizes disturbance to slope and lower vegetation and debris should be chipped and retained at a depth of no more than 3 inches within the forested area, away from stormwater lagoon.
